### SAMPLE PRE-PURCHASE ELECTRICAL INSPECTION REPORT

(Sample Report for Demonstration Purposes Only)

*Client Name:* John Murphy  
*Property Address:* 15 Oakwood Drive, Wexford  
*Inspection Date:* 01 July 2026  
*Report Number:* HS-2026-001  
*Inspector:* Nick Kendall  
*Property Type:* Semi-Detached House  
*Approximate Year Built:* 1988

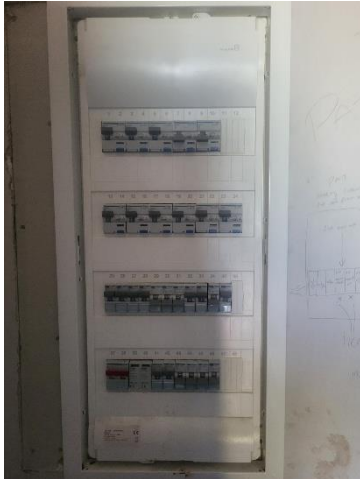
Existing Consumer Unit

The existing consumer unit is an older fuse type installation.

No residual current device (RCD) protection is provided.

The existing consumer unit is of an older DZ fuse design and does not provide modern RCD protection.

Upgrade consumer unit to a modern RCBO-protected consumer unit.

Upgrade to modern RCBO consumer unit.

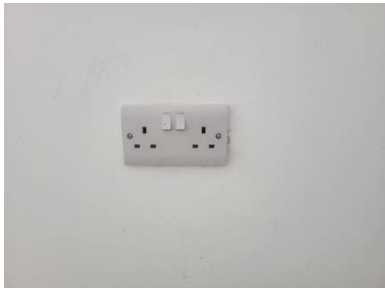
Damaged Socket Outlet

Two damaged socket outlets identified within kitchen area.

Evidence of wear and minor physical damage noted.

Socket outlet damaged with visible cracking to faceplate.

Replace damaged accessories.

Replace accessory.

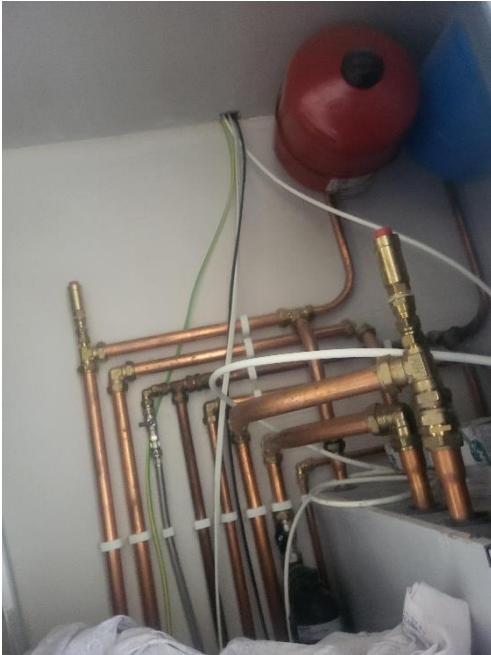
Missing Bonding Verification

Protective bonding to water services could not be fully verified at the time of inspection.

Protective bonding conductor could not be confirmed at incoming water services.

Further investigation and verification of bonding arrangements recommended.

Further investigation required.

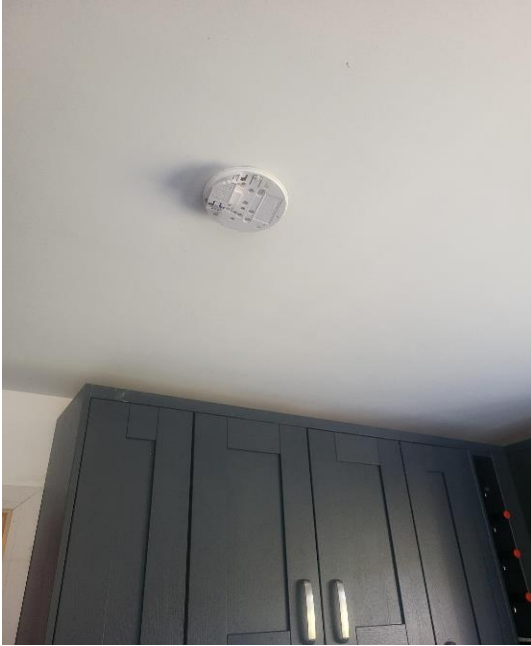
## Smoke Alarm Provision

One battery-operated smoke alarm present.

Alarm coverage does not meet current recommendations for a property of this size.

Single battery-operated detector present. Coverage insufficient for property layout.

Install interconnected smoke alarm system.

Upgrade to interconnected smoke alarm system.
